# Manhole Inspection Summary

Manhole # S23M\_\_003MH

Insp Date: **6/17/08 10:45 AM**

**Location** Address: **1543 Cole St**

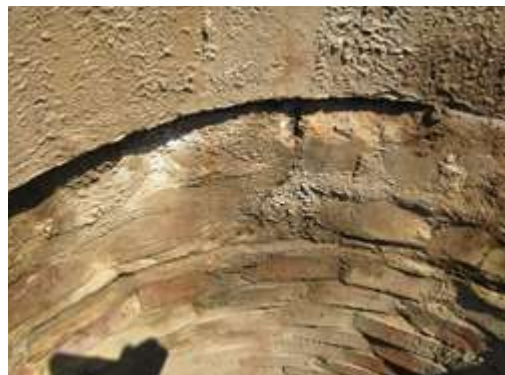
Defect 6

Condition: ☐ Sound ☐ Cracked ☒ **Leaks**

Infiltration: ☐ None ☒ **Joint** ☐ Cracks ☒ **Mortar** ☐ Roots ☒ **Wall**

frame leaks, chimney joint infiltration

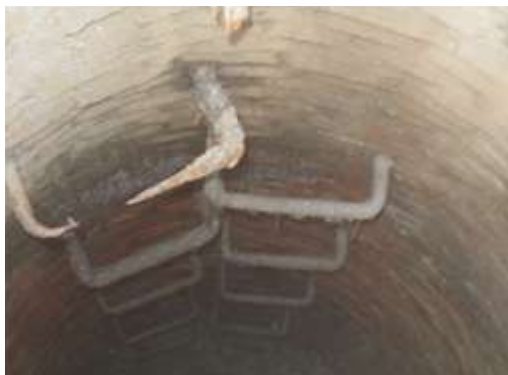
Defect 5

Infiltration: ☐ None ☐ Joint ☐ Cracks ☐ Mortar ☐ Roots ☒ **Wall**

Count: **9** Missing: **2** ☒ **Corroded**

steps corroded/missing, corbel infiltration at wall

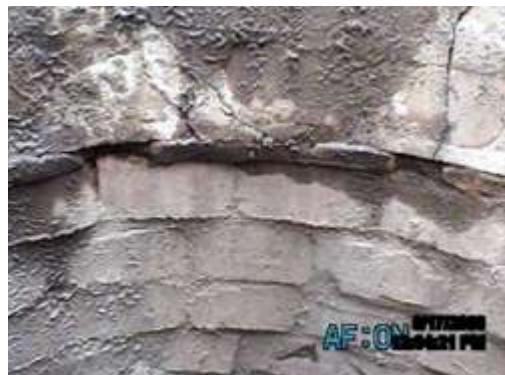
Defect 4

Condition: ☐ Sound ☒ **Cracked** ☐ Root Intrusion ☒ **Loose Brick** ☐ Deteriorated

chimney cracked & loose bricks with signs of infiltration from mortar & at wall

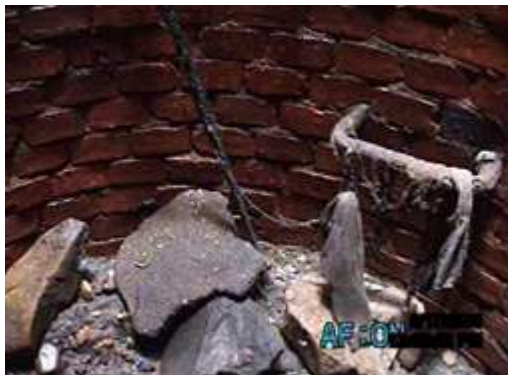
### Defect 2

Condition: ☐ Sound ☐ Cracked ☐ Root Intrusion ☐ Deteriorated ☐ Leaks ☒ **Debris**

☒ **Evidence Of Surcharge** Depth: **2** (ft.) ☐ Active Surcharge Present

bench debris, evidence of surcharge,  
barrel wall infiltration
